Milestone Phase One Inspection Report
 Beach Wood Villas Condominium Association

March 13, 2023

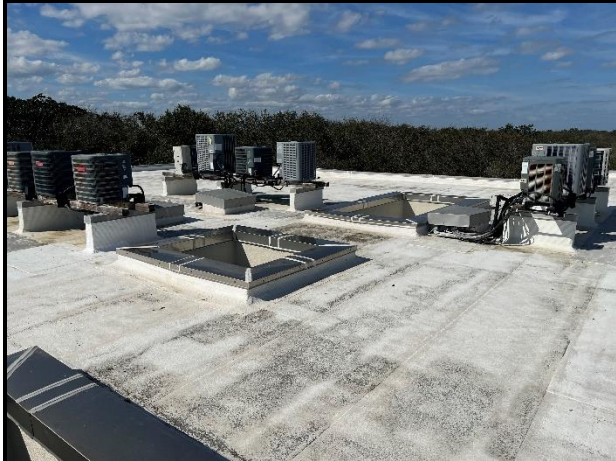
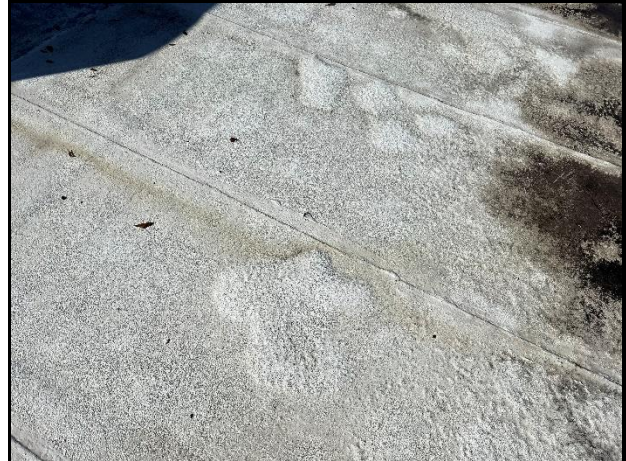
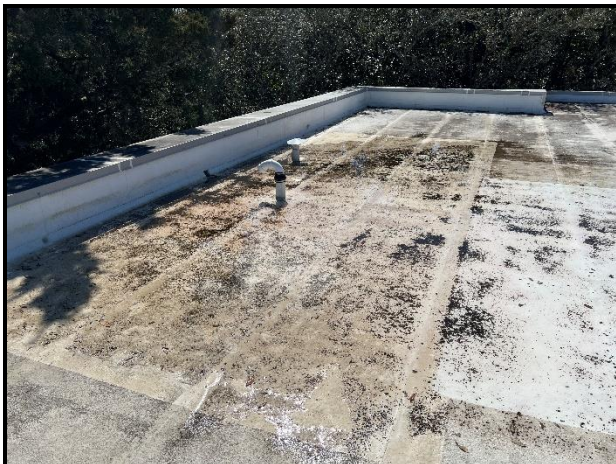
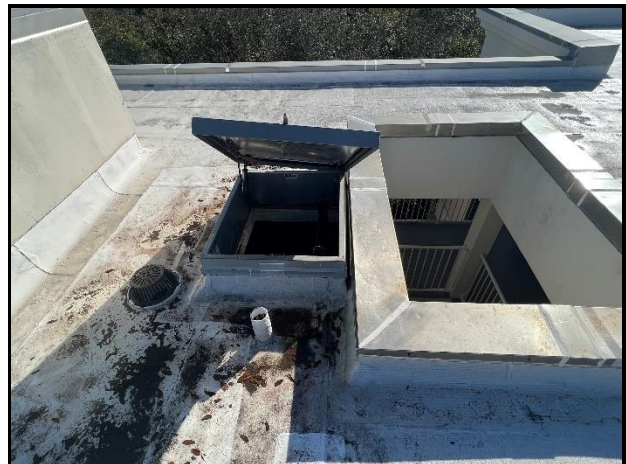
The low sloped roofs at Beach Wood are in fair condition. Numerous blisters were found in the roof systems as well as large areas of ponding. The roofs have atrium skylights that are not protected by guardrails. These skylight openings are in close proximity to the roof access hatches and mechanical equipment. These openings present a significant life-safety risk to anyone gaining access to the roof. Installation of fall protection guardrails is recommended.

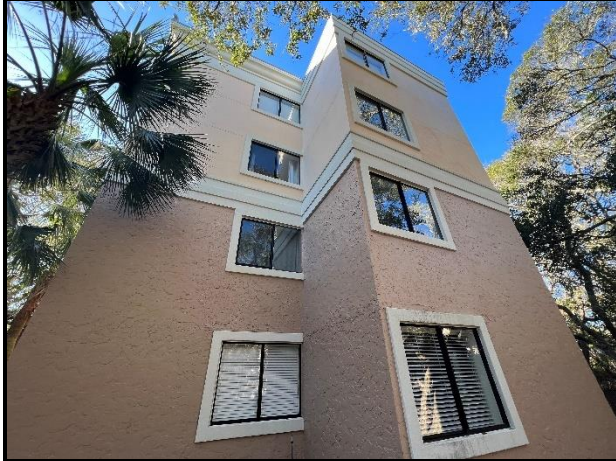
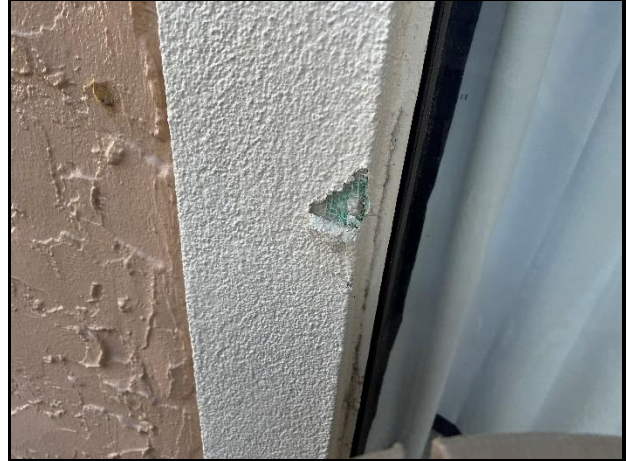
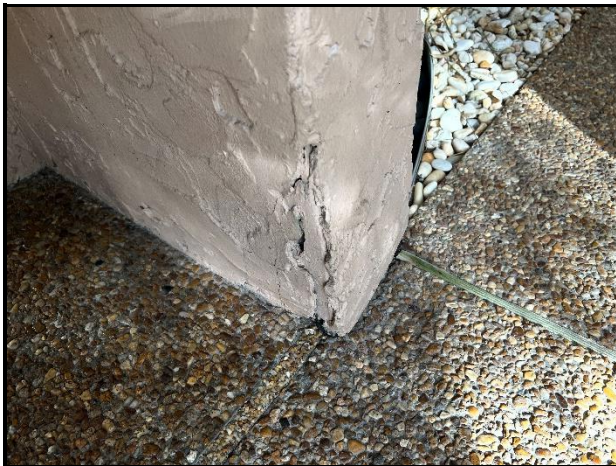
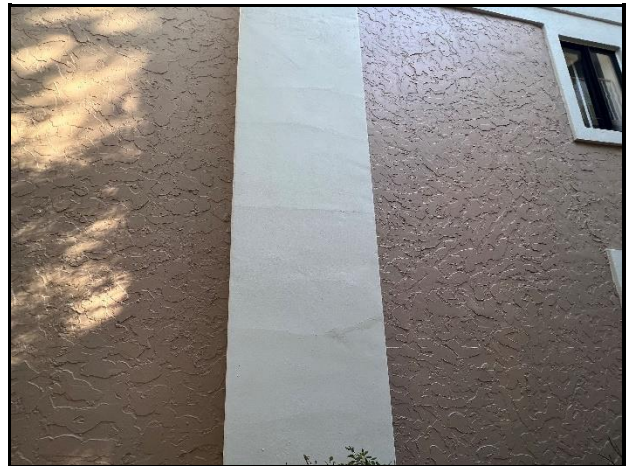
The exterior walls at Beachwood are in fair condition. Isolated impact damage was found on EIFS trim bands. Select wall corners have concrete spalls. Evidence of large stucco repairs were found.

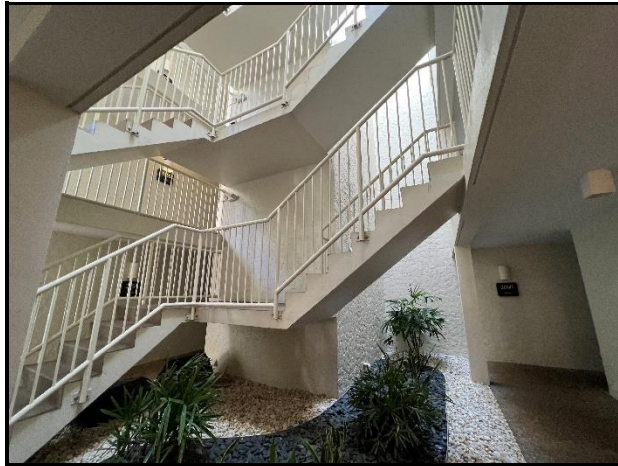
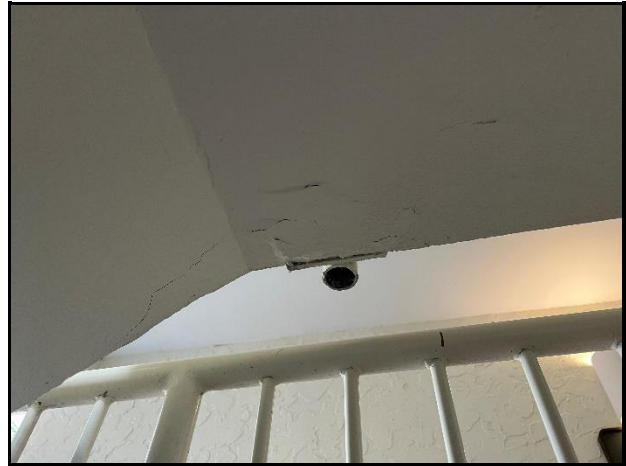
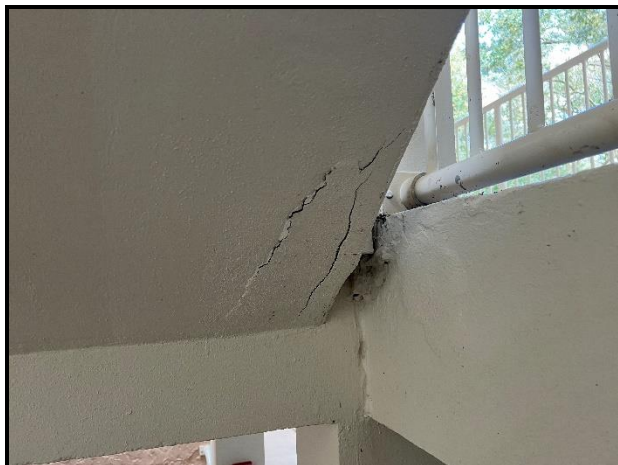
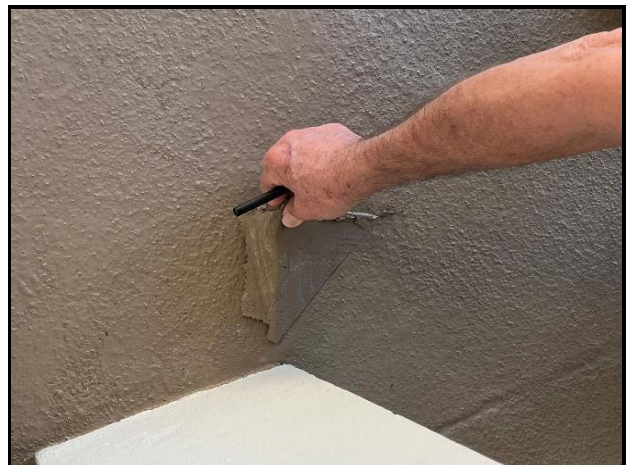
Additional Comments:
The stair towers located at Beach Wood are open to the environment. The guardrails installed have spalls near the anchor points. Some anchors are missing the required washer and nut. Concrete spalls are present on the shoulder and underside of the stair towers. The waterproofing is in fair condition. Past repairs are present and are separating from the original

waterproofing system. The railings on the stairs have a large openings below the base of the rails adjacent to the corners of the stair treads. This is a potential risk for injury.

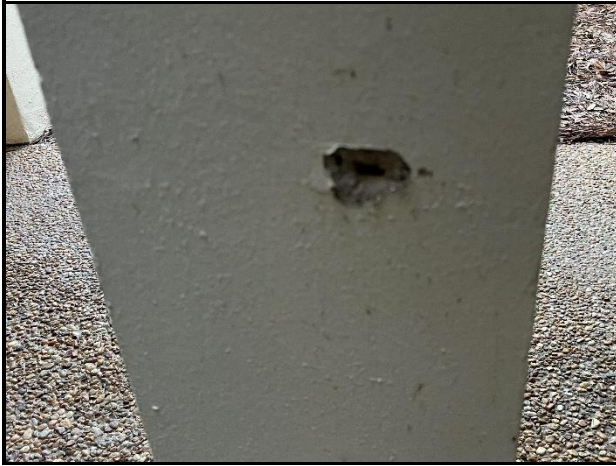
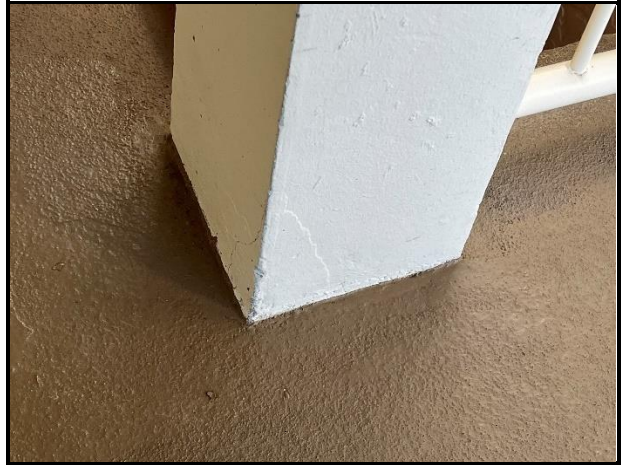
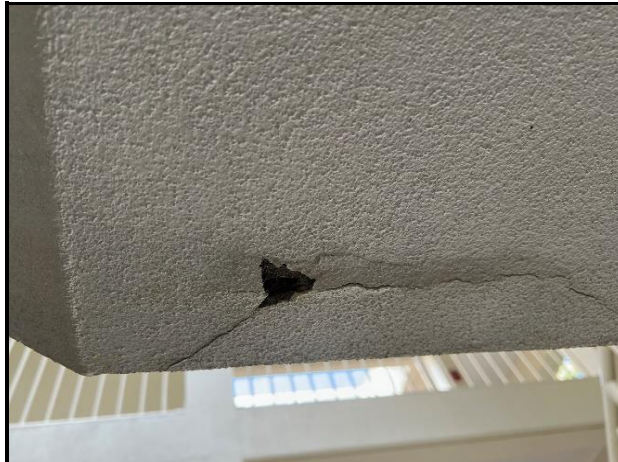
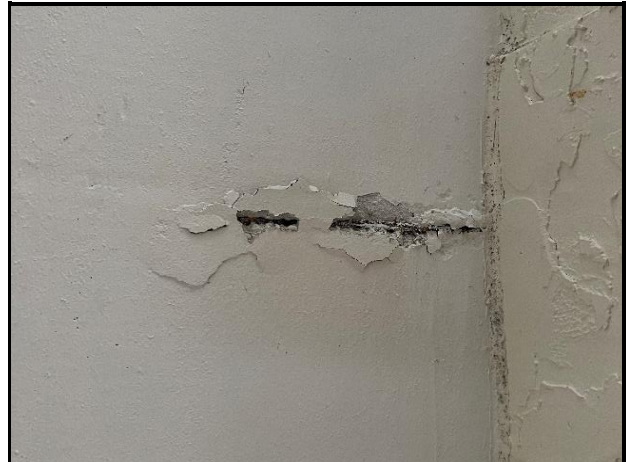
Additional Comments:
 The breezeways are open to the environment. Numerous spalls were found on the columns, beams, slab shoulder, and walls. Most spalls are minor. However, some are larger and require immediate repair. The waterproofing system is in fair condition. Previous repairs are separating from the original coating.

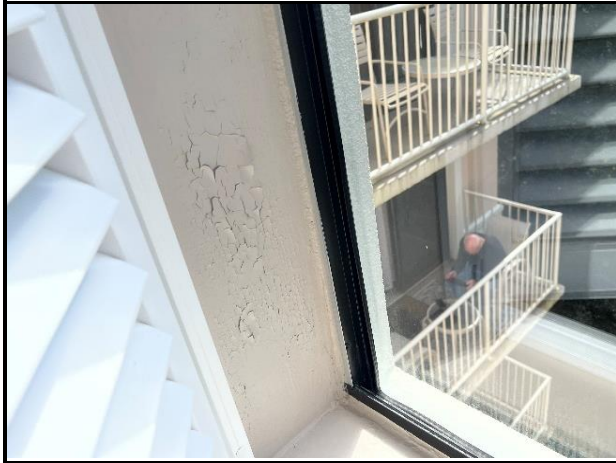
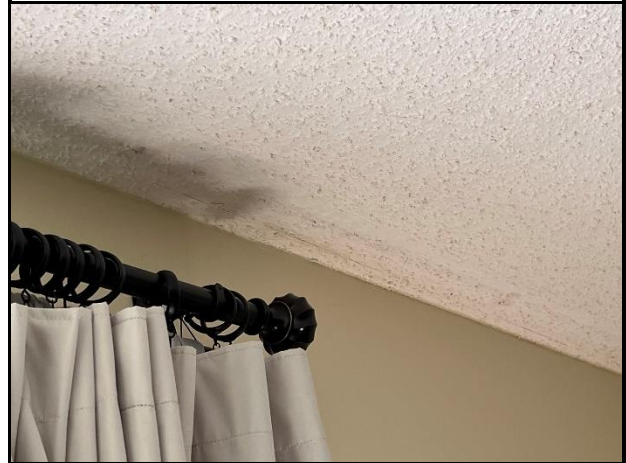
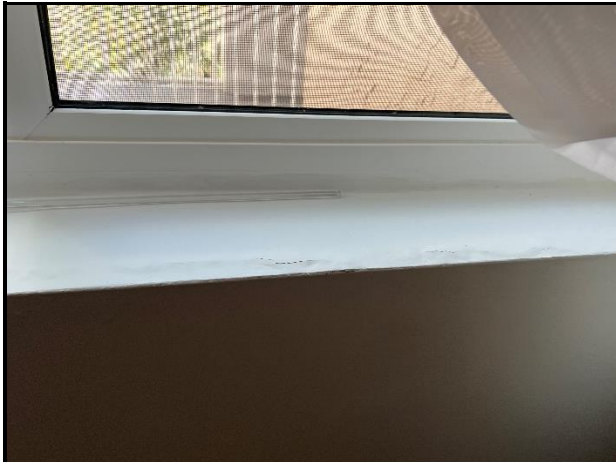
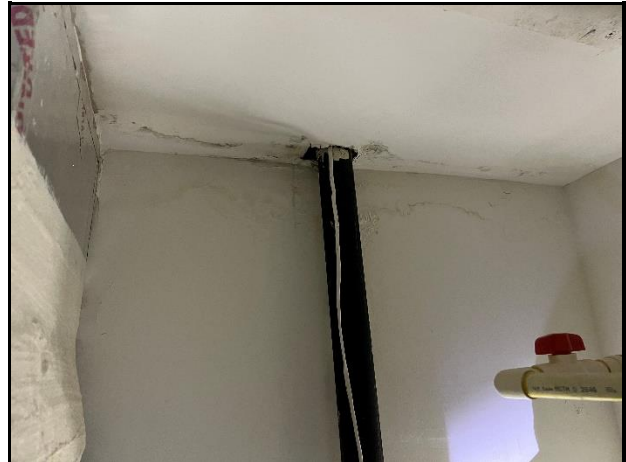
Additional Comments:
Evidence of water intrusion was noted in some utility room ceilings and on window sills.

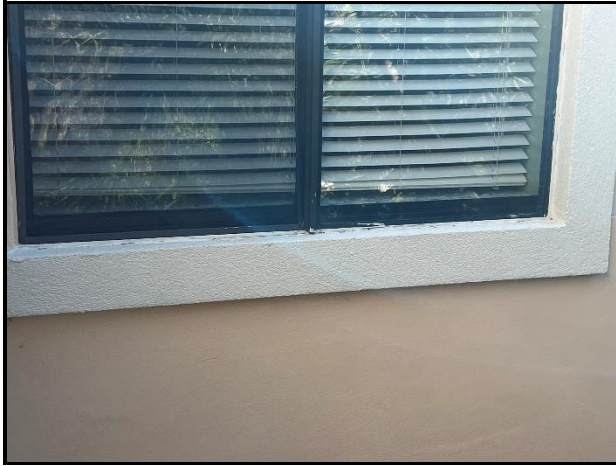
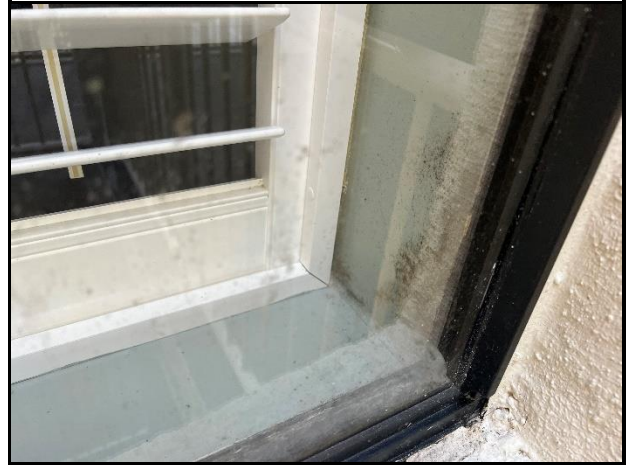
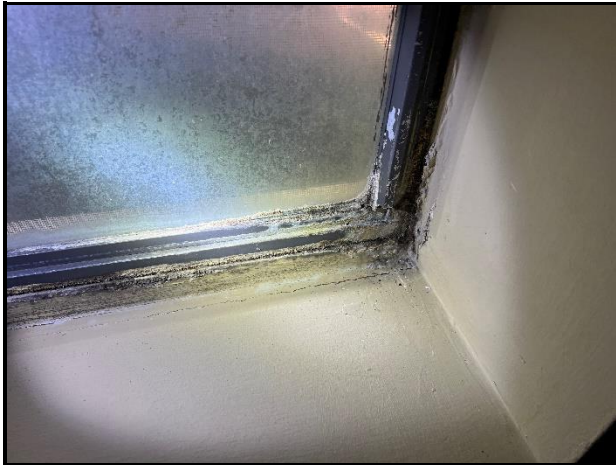
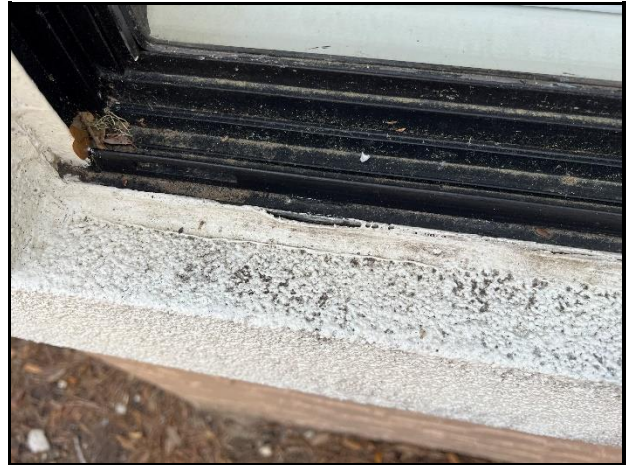
Additional Comments:
Windows range from original to new. Original windows have evidence of past leaks, causing microbial growth on select window sills. All original or aging windows are recommended to be replaced. All hardware used should be stainless steel. Newer windows have the EIFS trim bands tight to the frame, not allowing for a proper bead of sealant to be installed.

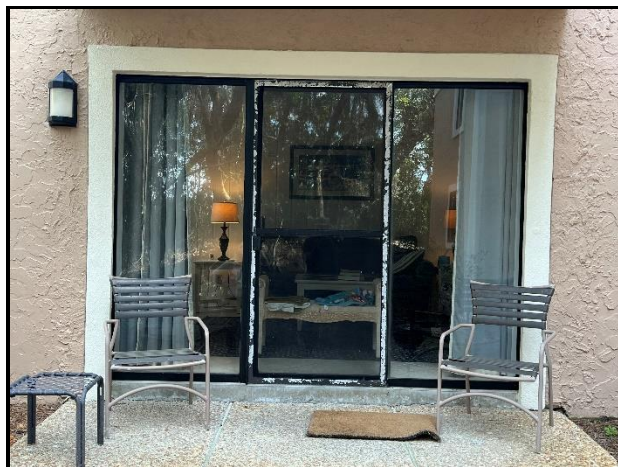
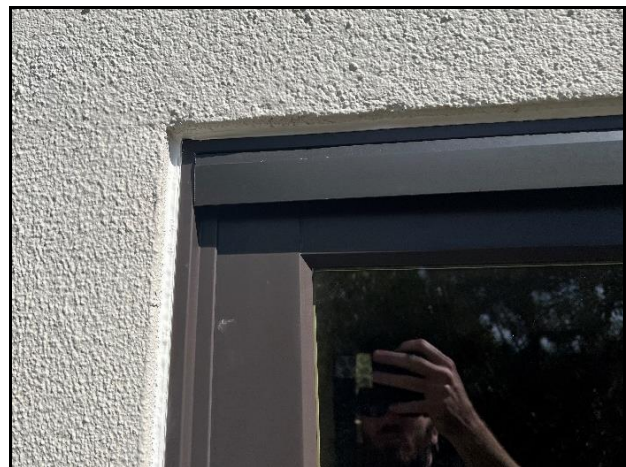
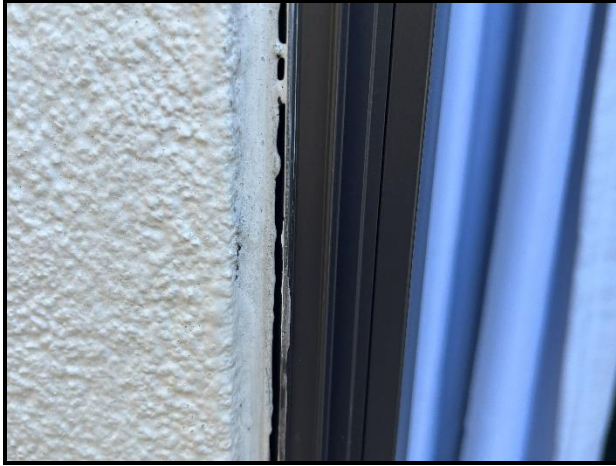
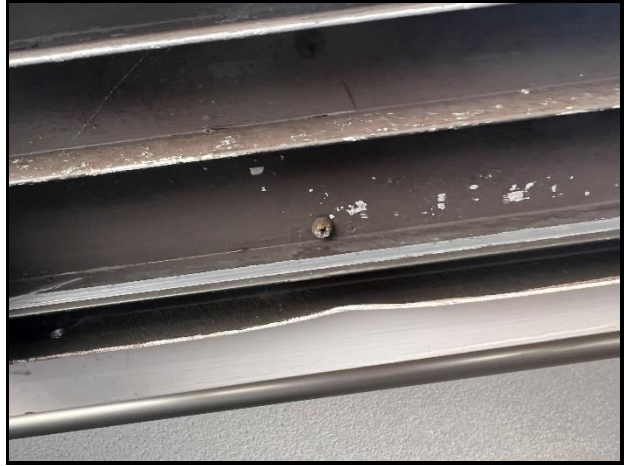
Additional Comments:
Doors range from original to new. Original doors have evidence of past leaks. All original or aging doors are recommended to be replaced. All hardware used should be stainless steel. Newer doors have the EIFS trim bands tight to the frame, not allowing for a proper bead of sealant to be installed.
