**Structural Integrity Reserve Study
Beach Wood Villas Association
Amelia Island, Florida**

**Prepared for FY 2025
Report Date: July 24, 2024**

Re: Reserve Study Report for Beach Wood Villas Association

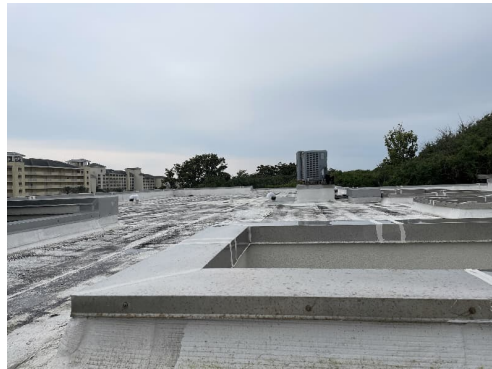
Membrane Roof - Condo Central - 2034

Typical useful life for this type of roof is 20 years. This roof has been coated with a high quality roof coating we assume will extend the life additional years. A annual rooftop inspection by the coating manufacturer is recommended to maintain the warranty.

Last Renovation: Feb. 2020 Product: One Step MD Roof Coating and roof equipment repair
Contractor: McCurdy-Walden Inc., Commercial Roofing (904) 783-9025

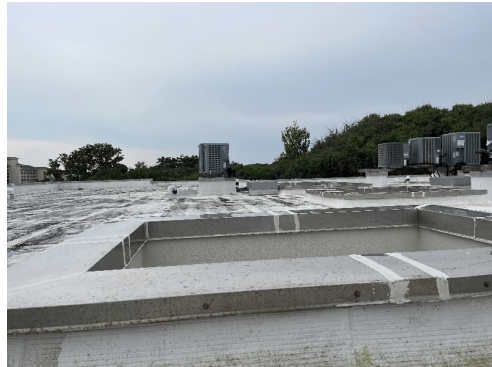
Membrane Roof - Condo North continued...

Typical useful life for this type of roof is 20 years. This roof has been coated with a high quality roof coating we assume will extend the life additional years. A annual rooftop inspection by the coating manufacturer is recommended to maintain the warranty.

Last Renovation: Feb. 2020 Product: One Step MD Roof Coating and roof equipment repair

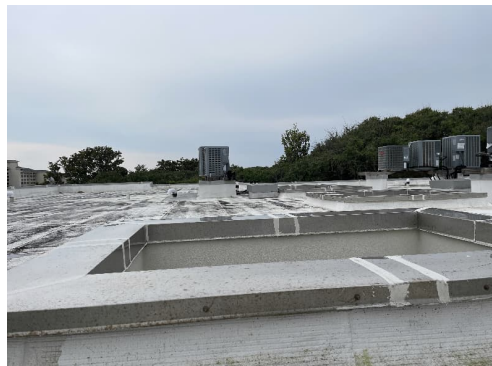
Membrane Roof - Condo South - 2034

Typical useful life for this type of roof is 20 years. This roof has been coated with a high quality

roof coating we assume will extend the life additional years. A annual rooftop inspection by the coating manufactor is recommended to maintain the warranty.

Last Renovation: Feb. 2020 Product: One Step MD Roof Coating and roof equipment repair

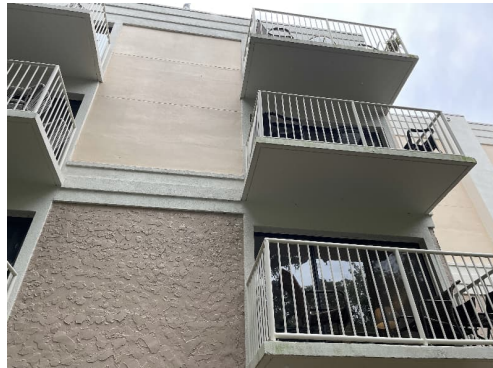
Concrete Restoration Allowance - Balconies - 2029

Asset ID	1127	72 Units	@ \$500.00
		Asset Actual Cost	\$36,000.00
		Percent Replacement	100%
Category	Structural Components	Future Cost	\$41,310.83
Placed in Service	January 2004		
Useful Life	25		
Replacement Year	2029		
Remaining Life	4

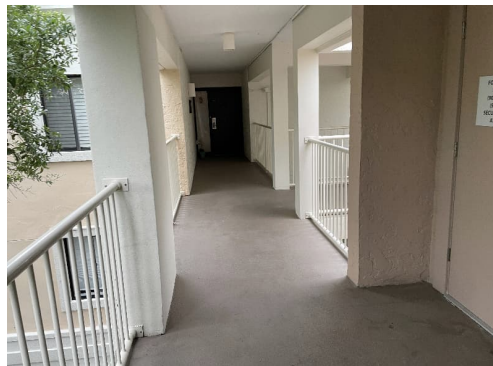
Concrete Restoration Allowance - Walkways - 2029

Asset ID	1128	12 Levels	@ \$3,000.00
		Asset Actual Cost	\$36,000.00
		Percent Replacement	100%
Category	Structural Components	Future Cost	\$41,310.83
Placed in Service	January 2004		
Useful Life	25		
Replacement Year	2029		
Remaining Life	4

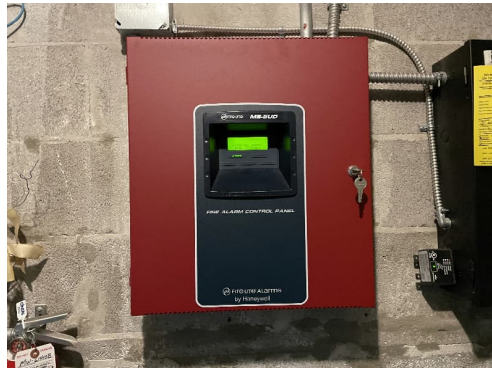
Fire Alarm Panel - Condo Central - 2025

Asset ID	1131	1 Each	@ \$4,800.00
Category	Fireproofing	Asset Actual Cost	\$4,800.00
Placed in Service	January 2004	Percent Replacement	100%
Useful Life	20	Future Cost	\$4,800.00
Replacement Year	2025		
Remaining Life	0

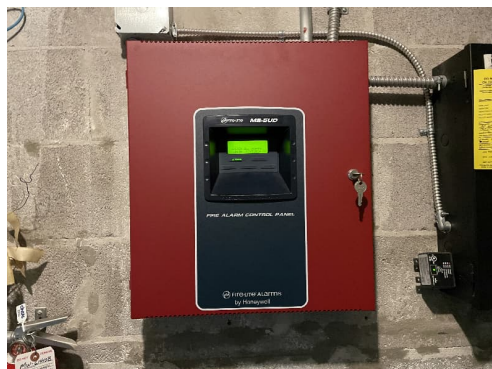
Fire Alarm Panel - Condo North - 2025

Asset ID	1129	1 Each	@ \$4,800.00
Category	Fireproofing	Asset Actual Cost	\$4,800.00
Placed in Service	January 2004	Percent Replacement	100%
Useful Life	20	Future Cost	\$4,800.00
Replacement Year	2025		
Remaining Life	0

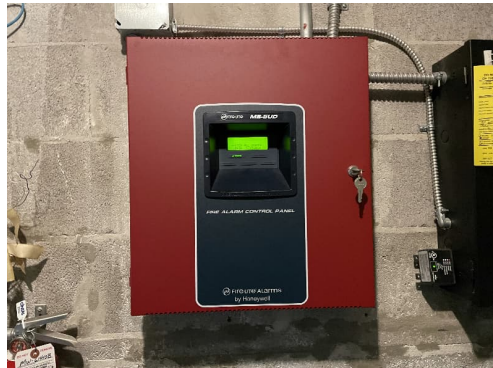
Fire Alarm Panel - Condo South - 2025

Asset ID	1130	1 Each	@ \$4,800.00
Category	Fireproofing	Asset Actual Cost	\$4,800.00
Placed in Service	January 2004	Percent Replacement	100%
Useful Life	20	Future Cost	\$4,800.00
Replacement Year	2025		
Remaining Life	0

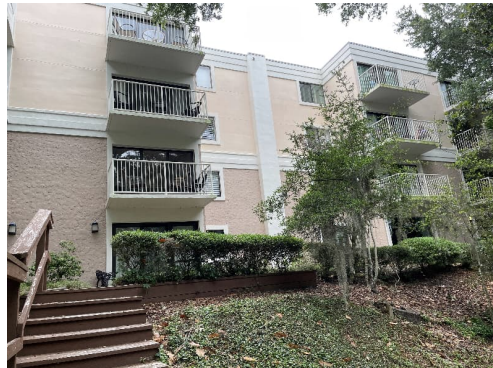
Balcony Railings - Condo Central - 2036

Asset ID	1085	380 Linear Feet	@ \$78.00
		Asset Actual Cost	\$29,640.00
		Percent Replacement	100%
Category	Building Components	Future Cost	\$43,273.50
Placed in Service	January 2006		
Useful Life	30		
Replacement Year	2036		
Remaining Life	11

- Aluminum railing at balconies should be inspected annually and repaired for safety. Recommend that inspection, cleaning, and painting are done as needed.

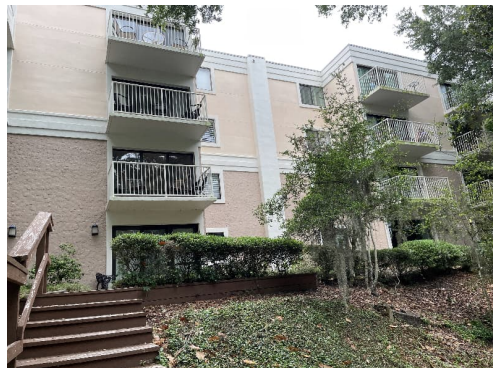
Balcony Railings - Condo North - 2036

Asset ID	1086	380 Linear Feet	@ \$78.00
		Asset Actual Cost	\$29,640.00
		Percent Replacement	100%
Category	Building Components	Future Cost	\$43,273.50
Placed in Service	January 2006		
Useful Life	30		
Replacement Year	2036		
Remaining Life	11

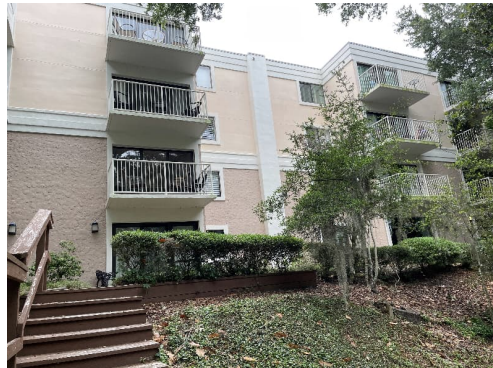
Balcony Railings - Condo South - 2036

Asset ID	1089	380 Linear Feet	@ \$78.00
		Asset Actual Cost	\$29,640.00
		Percent Replacement	100%
Category	Building Components	Future Cost	\$43,273.50
Placed in Service	January 2006		
Useful Life	30		
Replacement Year	2036		
Remaining Life	11
